Queensbury Tunnel

Phase 2: Technical Summary
Structure Number: HQU/3D

City of Bradford Metropolitan District Council

Project number: 60582061
Report: 60582061-REP-006
Issue 02

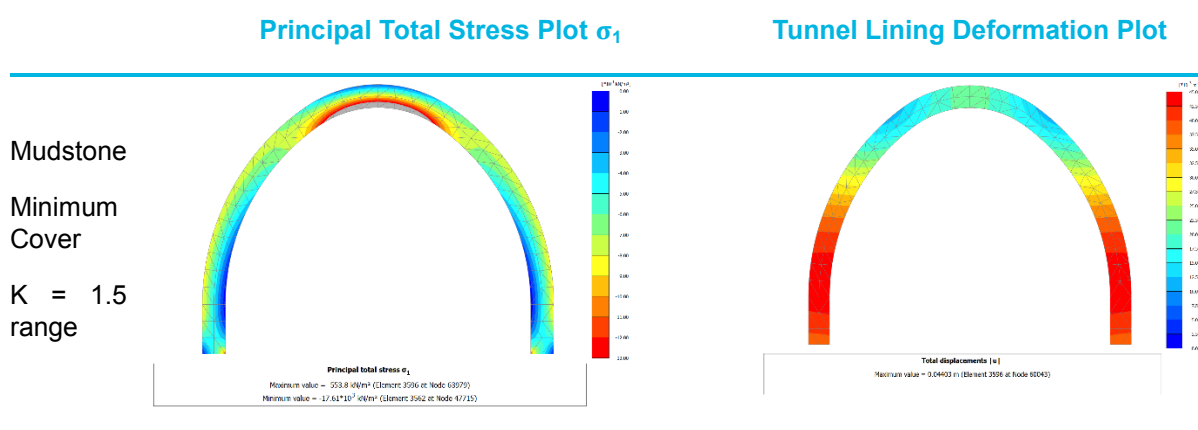
Figure 4: Extract – Plaxis FE Analyses – Mudstone horizon – Low cover

Here, analyses indicate that the (brick) tunnel lining's capacity is partially exceeded within the soffit of the tunnel (grey zone).

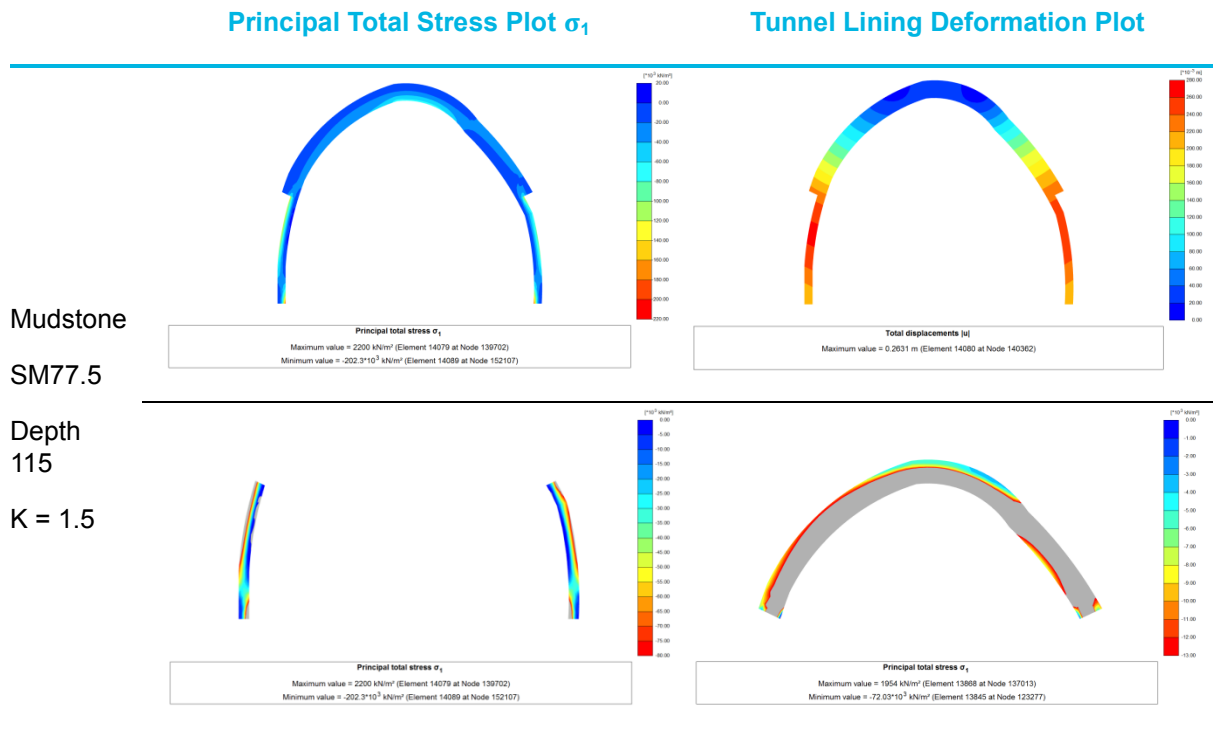
Figure 6: Extract – Plaxis FE Analyses – Mudstone Horizon – Deformed Profile SM77.5

In the above example, analyses indicate that, when considering existing deformations and the refinement to the tunnel sidewall lining properties, the sidewall show signs of high compressive stresses on the extrados and localised tensile stresses on the intrados. This is still considered to be within capacity, albeit with highly stressed zones. The crown of the tunnel shows that the compressive stresses are far greater than the assumed compressive capacity of the brick lining. It is therefore considered to be out of capacity.

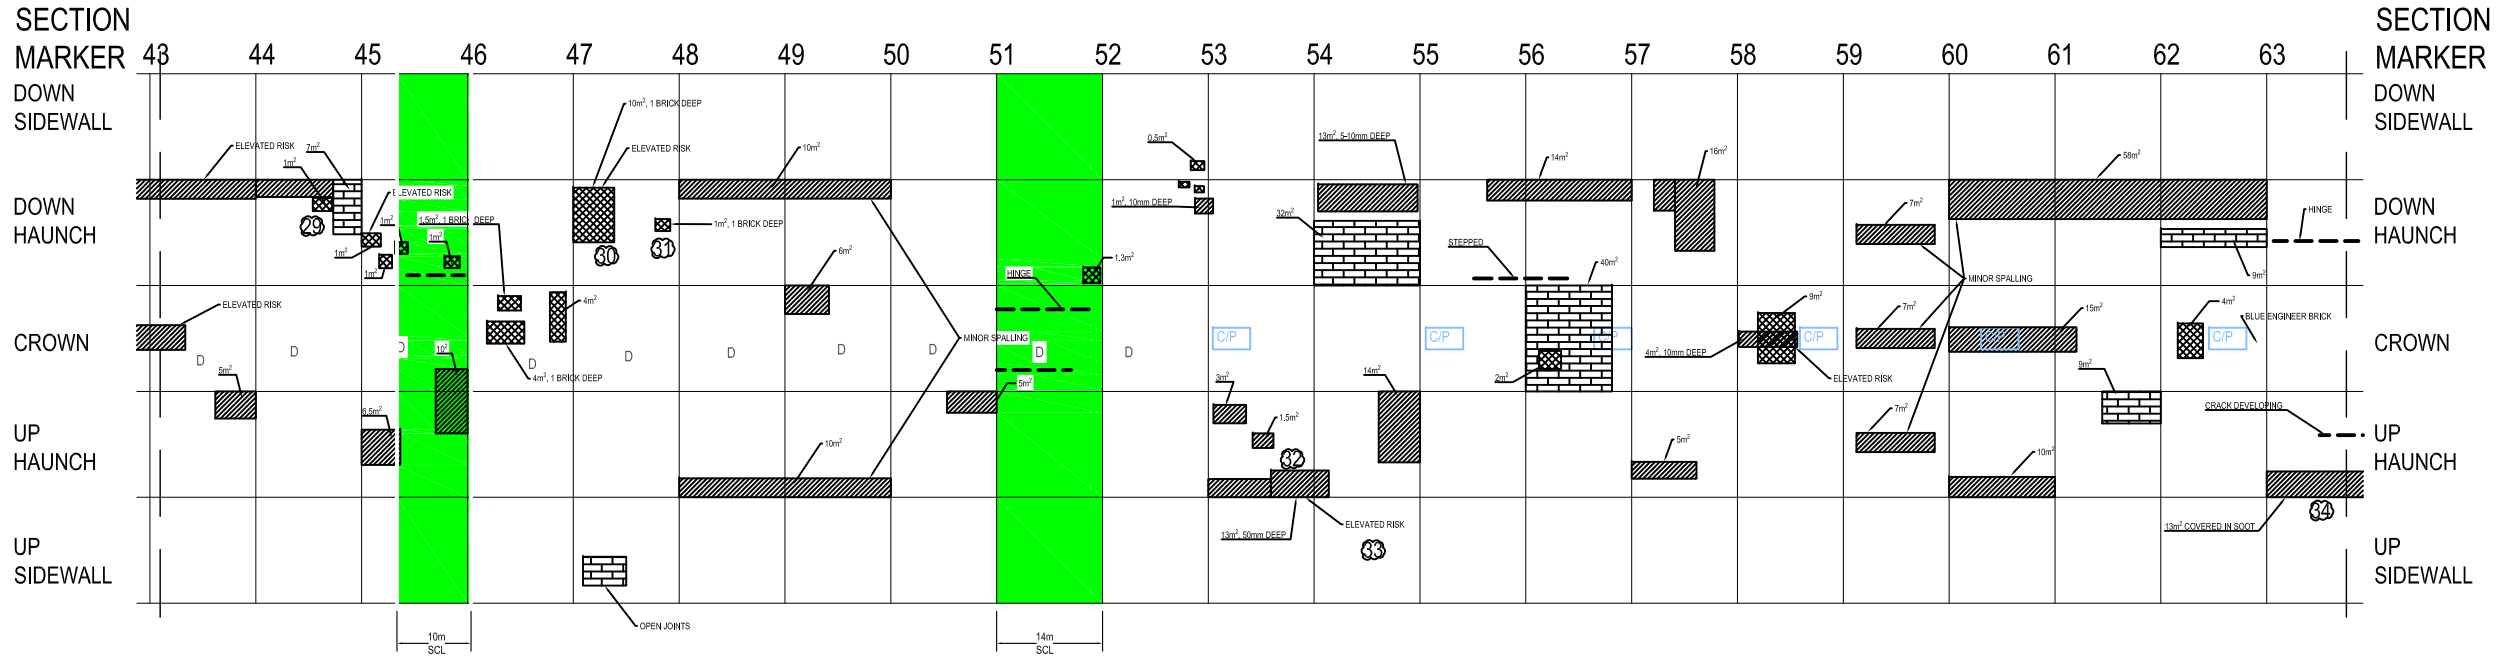
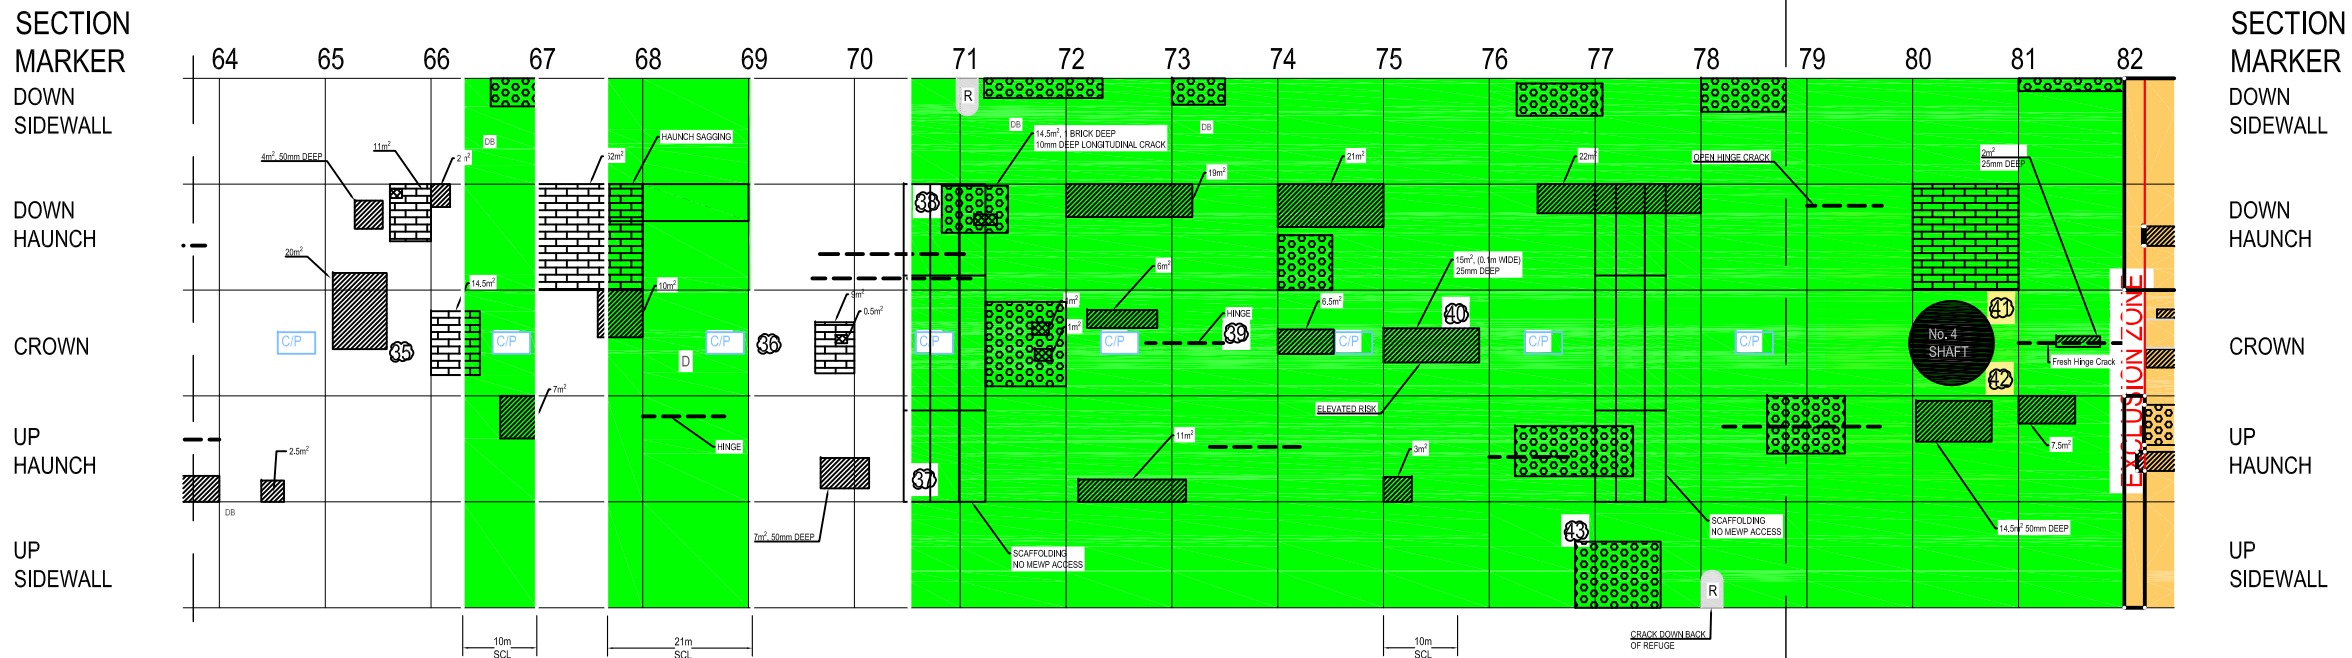
Schedule of Existing Defects Northern Sections SM43 - SM82

EXCLUSION ZONE EXTENDED TO
HERE, AS OF 23/08/2018

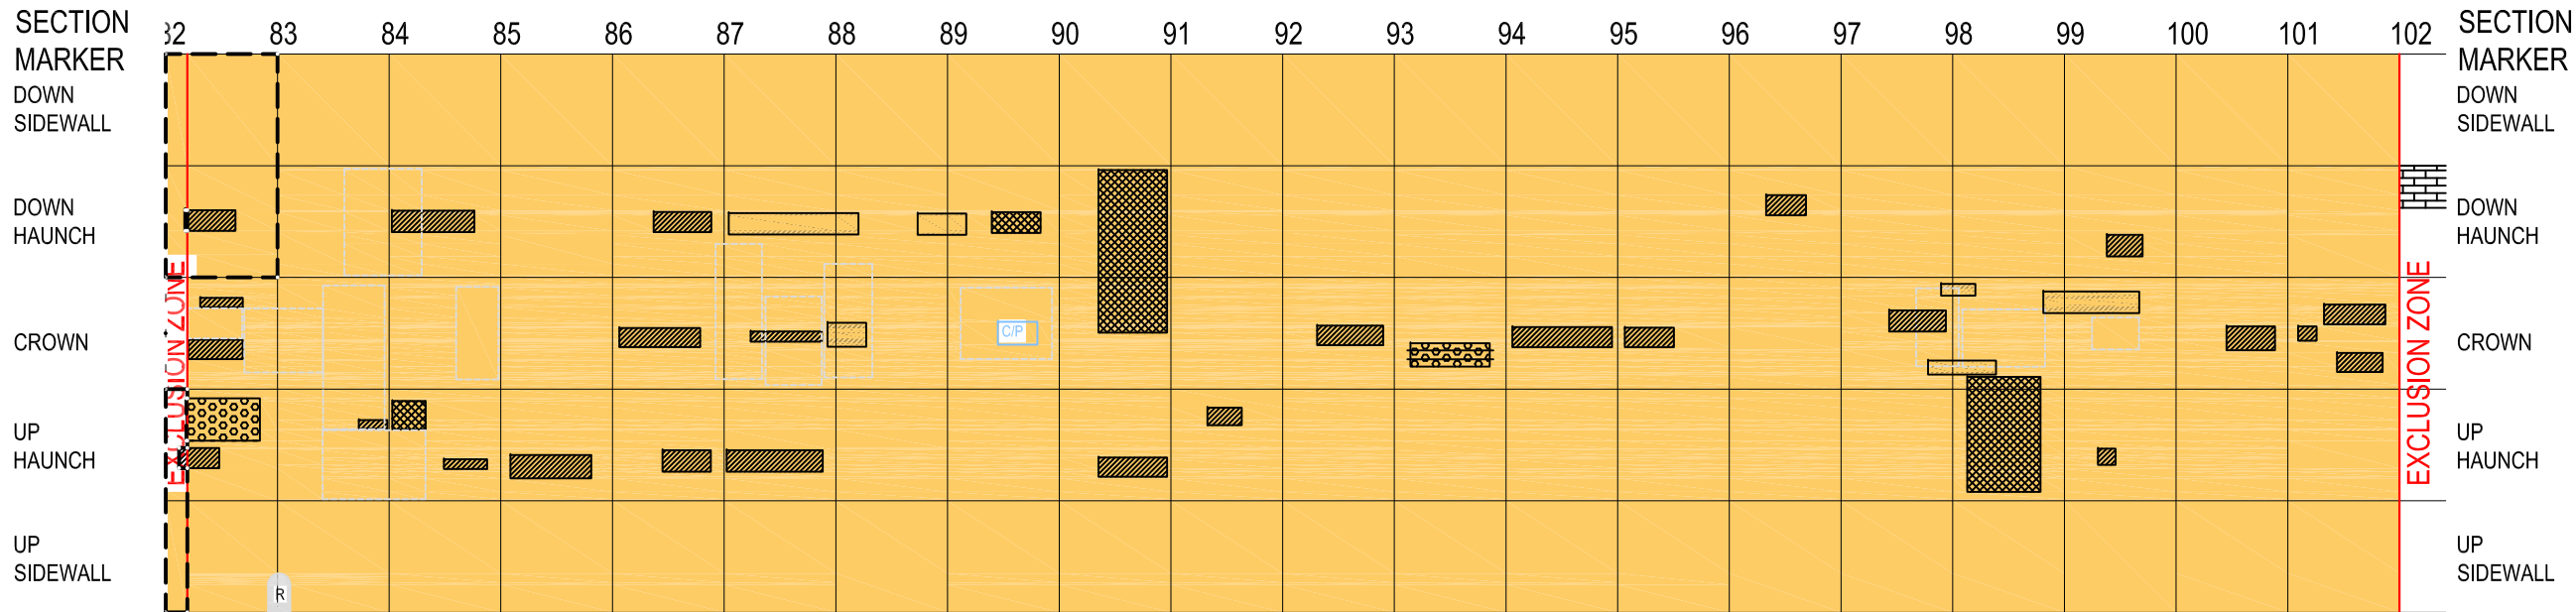
EXCLUSION ZONE EXCLUDED FROM THIS ASSESSMENT
DEFECTS SHOWN BASED ON QTS TUNNEL CONDITION REPORT
