Queensbury Tunnel Options Report

The Historical Railways Estate (HRE), part of Highways England, examines and maintains around 3,200 disused railway structures. Of that number, the 2,501-yard (2,287 metres) long Queensbury Tunnel - between Bradford and Halifax in West Yorkshire - has the highest risk profile. This is due to its deteriorating condition, difficulties with access and the close proximity of dwellings to four of its construction shafts.

Current condition

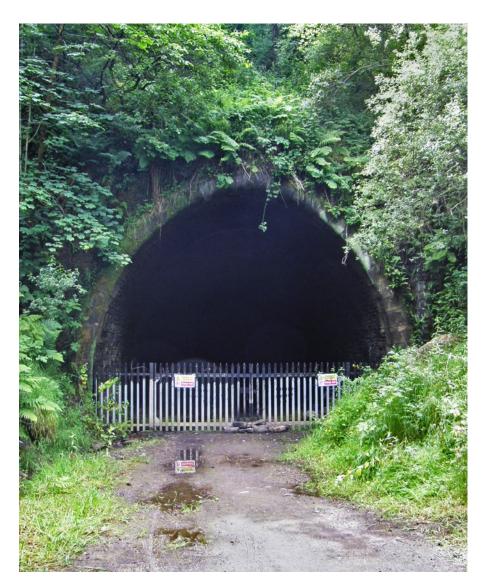
Contemporary photo of the north portal. Most of the parapet/copings are missing, as are the wing walls on both sides.

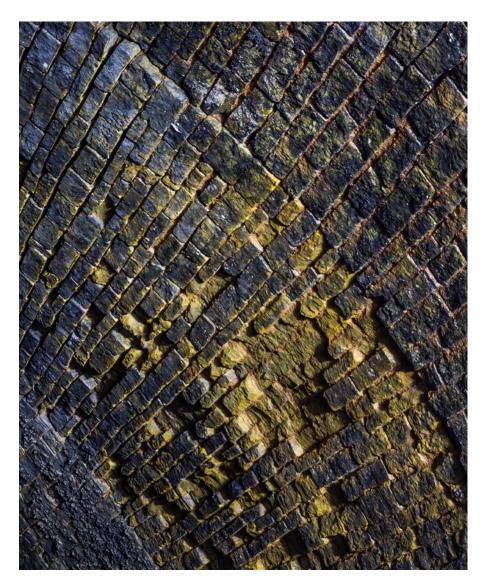
Spalled stonework and bulge at U/S haunch.

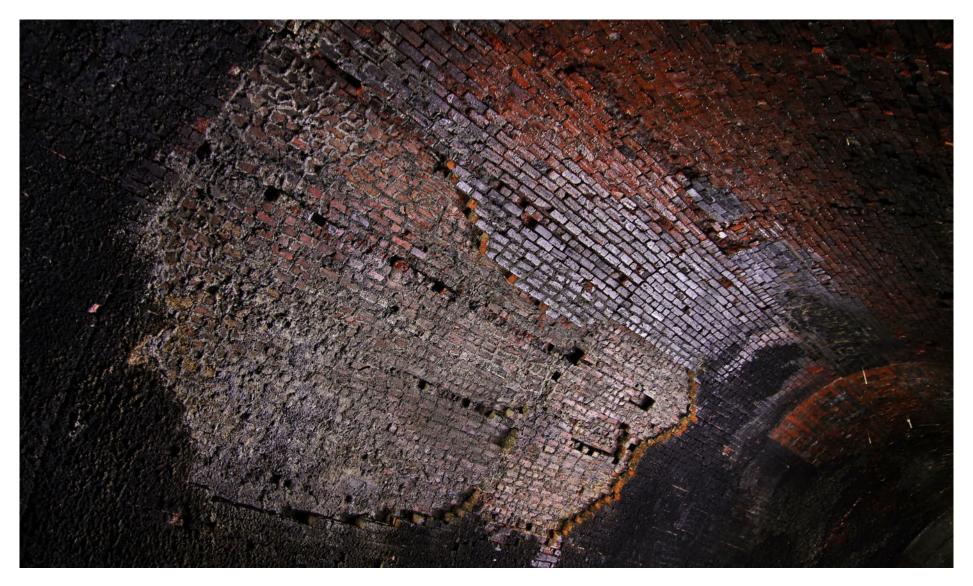
Typical area of missing outer brick ring at the north end of the tunnel. In many cases, these areas were removed (the brickwork having become loose) to provide safe access for staff carrying out grouting/waterproofing experiments in the 1990s.

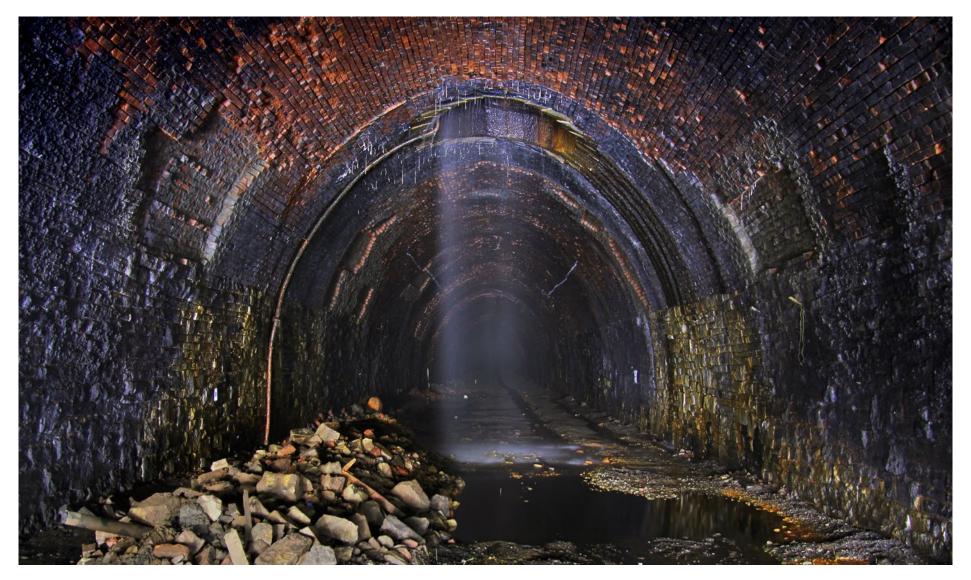
General view of No.8 shaft showing areas of missing brickwork. The arch at the other shafts is built in stone.

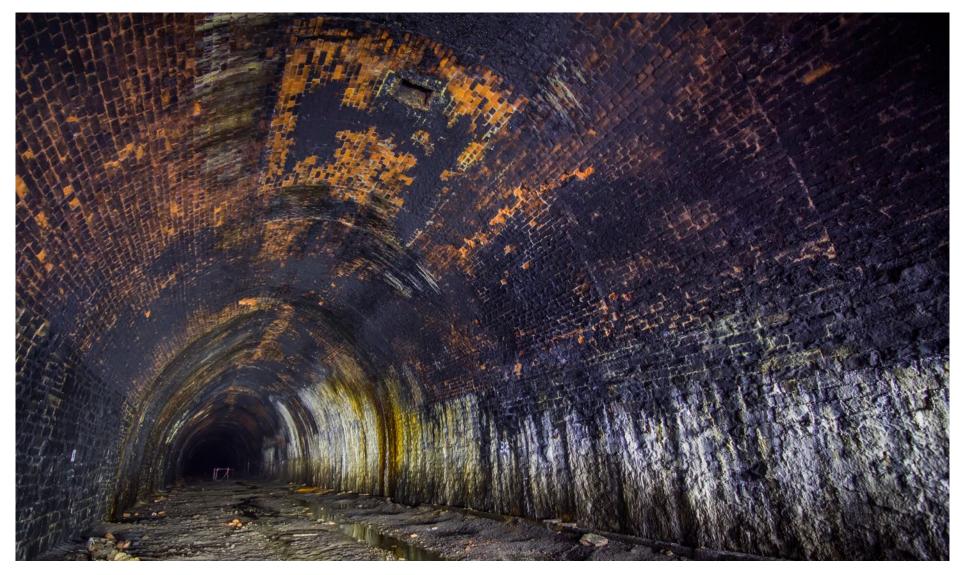
Wide view through the area of 1883 sidewall and arch repairs, showing some crushing of brickwork at the crown and spalling at U/S low/mid haunch alongside the inspection hatch.

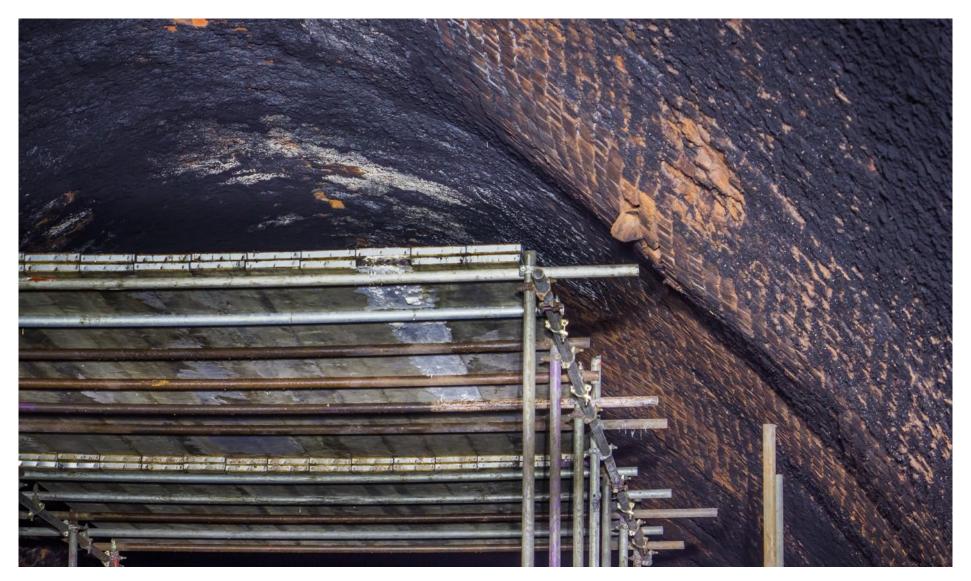
Severe bulge at D/S haunch, with loose/hanging/spalled bricks and open joints.

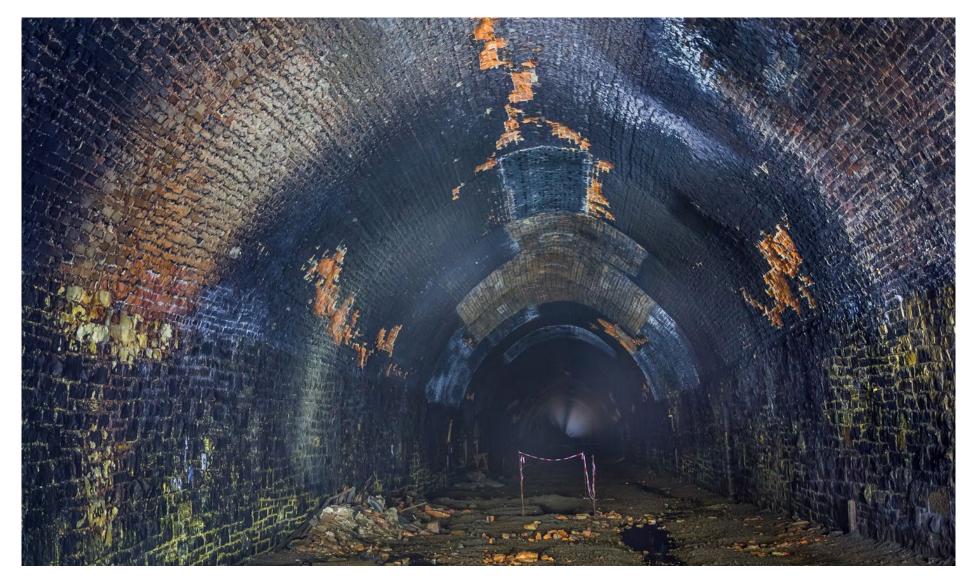
Spalling at crown and low haunches (1 brick deep) on both U/S and D/S. Severe bulge at U/S haunch. D/S haunch heavily repointed close to camera. Note 1920s arch repairs.

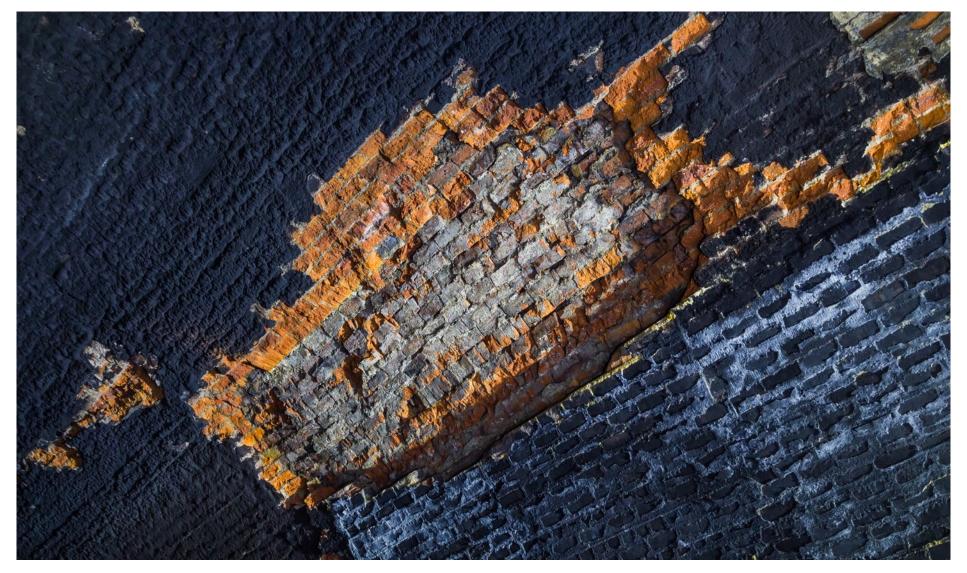
Missing brickwork at U/S haunch (1-2 bricks deep) above patch repair.

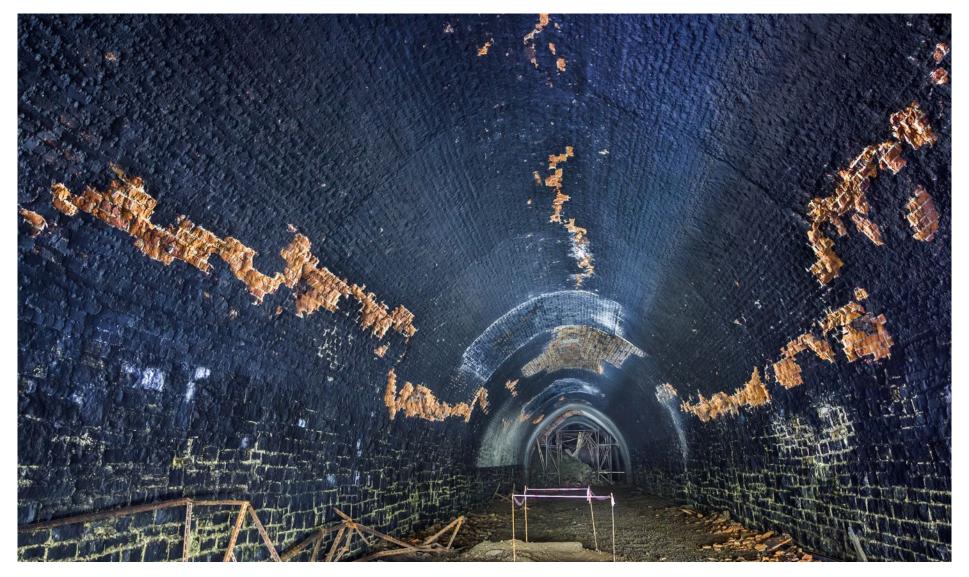
Spalling at crown and low/mid haunches (1-2 bricks deep) on both U/S and D/S. Significant flattening of arch at U/S high haunch. Note 1920s arch repairs towards collapse.

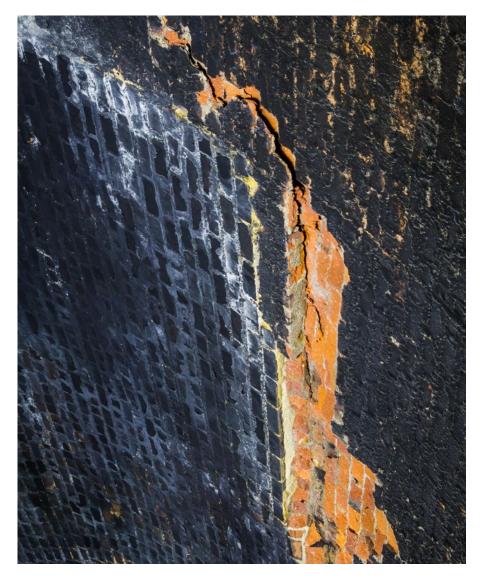
greater strain. One consequence of this is that a number of repair panels are separating from the rest of the arch and lipping over the adjacent brickwork, partly as a function of poor bonding.

Outer brickwork ring separating from arch below patch repair and lipping adjacent brickwork.

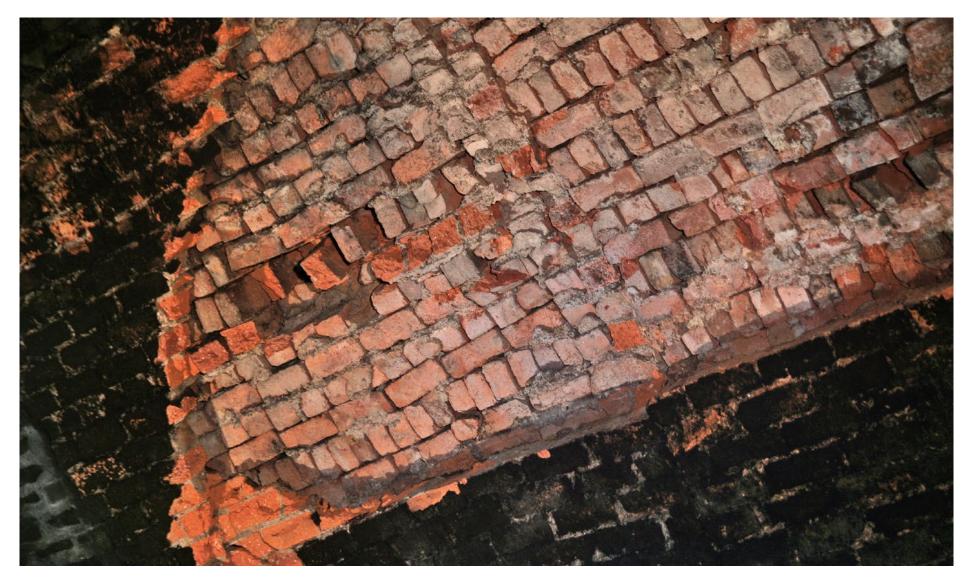
2007 view of missing brickwork at D/S haunch where collapse occurred in February 2013.

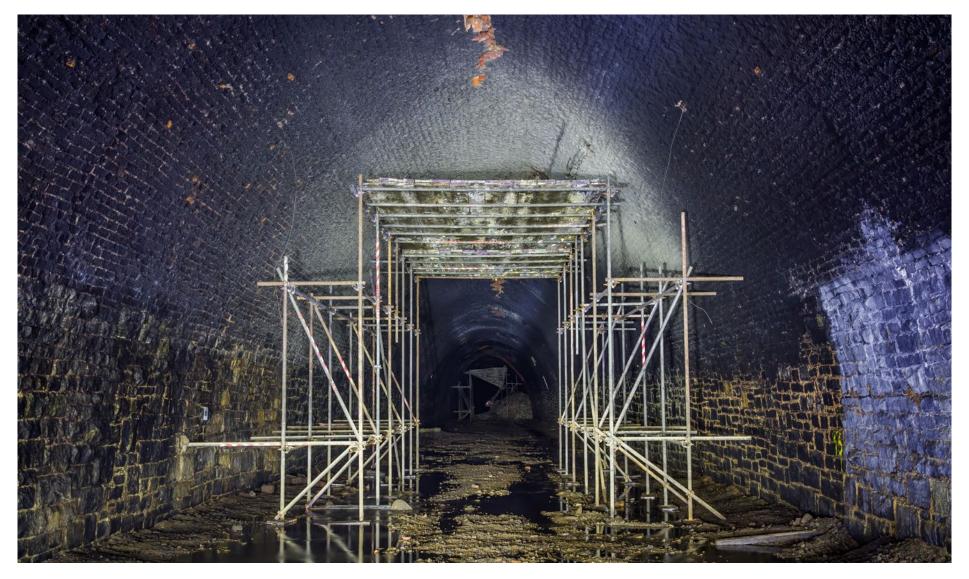
At tabs 93-94, a longitudinal fracture developed in the U/S high haunch which was stabilised using wedges. Between 2010-2013, the lining sheared at the southern end of this fracture, causing another to form parallel with it and pushing the higher part of the arch upwards by ~200mm, over the adjacent brickwork.

Longitudinal fracture at U/S high haunch, packed with wedges. At the south end, lining has displaced upwards by ~200mm.

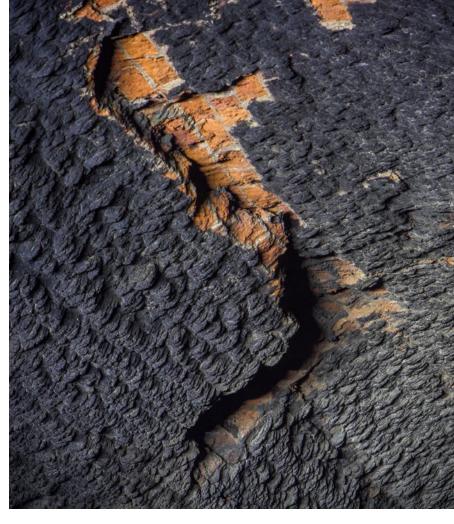
Displaced lining at south end of fracture.

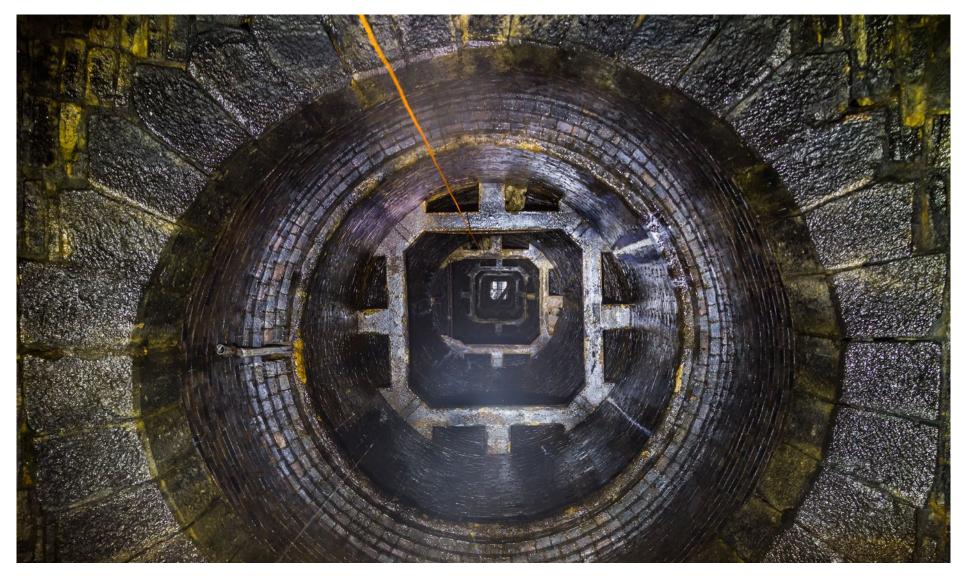
View up No.3 shaft showing brick relining and reinforced concrete frames, added for strengthening in 1934/5.

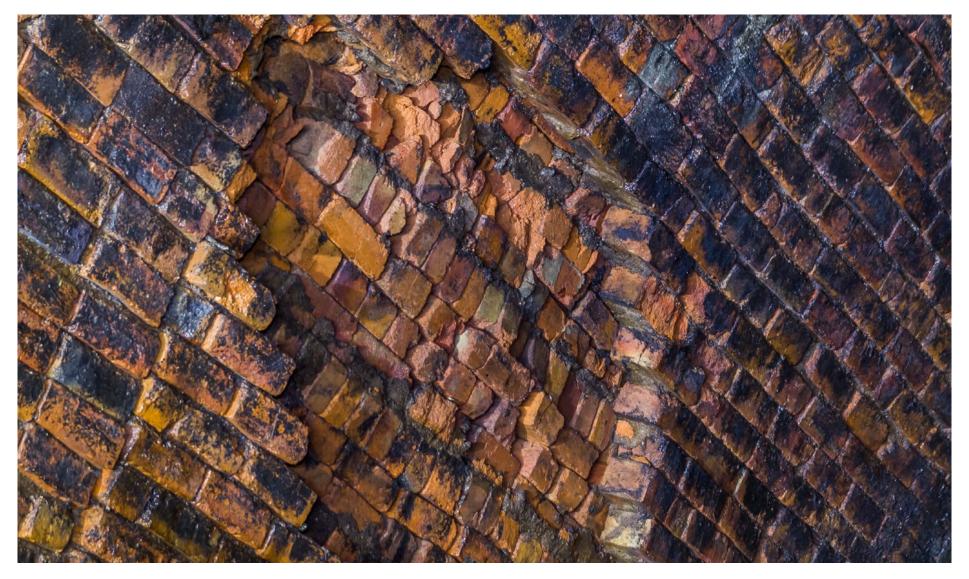
Typical area of missing outer brick ring. Note, very little mortar and two courses of brick on edge.

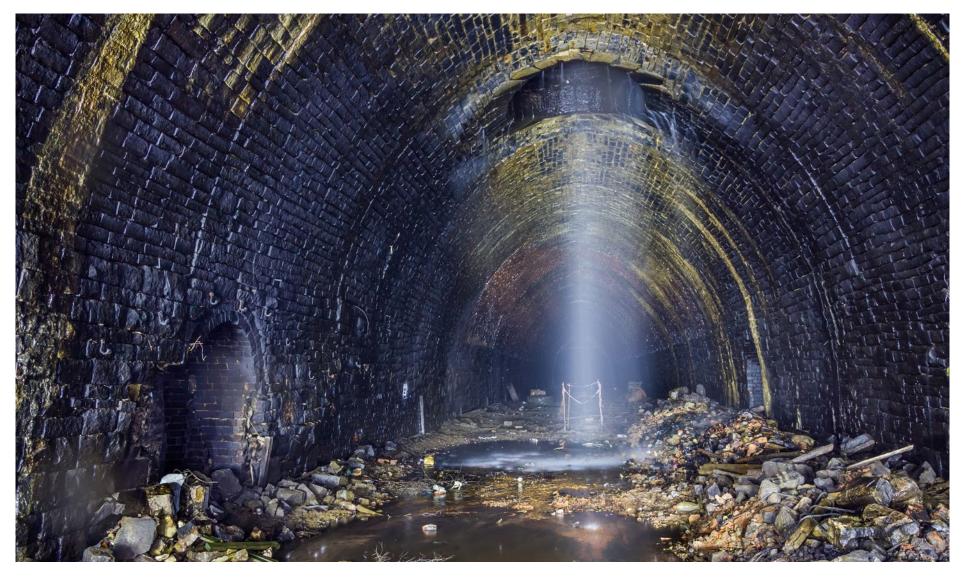
General view of No.2 shaft showing volume of water.

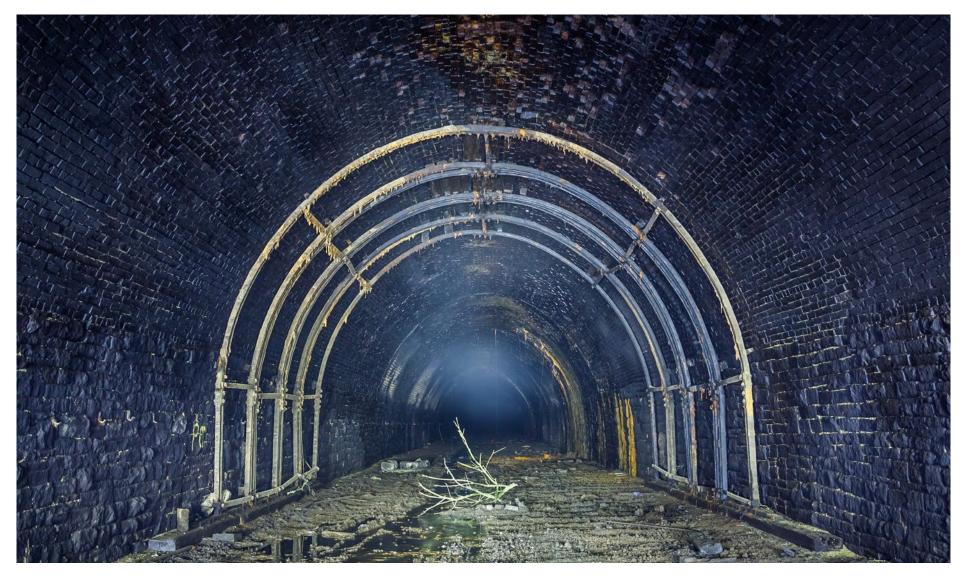
Section of arch ribbing with some laggings in situ. Spalled/wet/missing brickwork at crown.

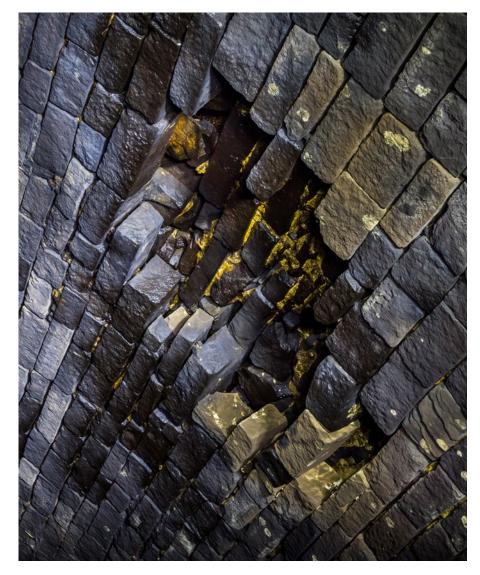
Missing stonework at D/S haunch.
