# Queensbury Tunnel

Risk to the Community

J U L Y 2 0 1 8

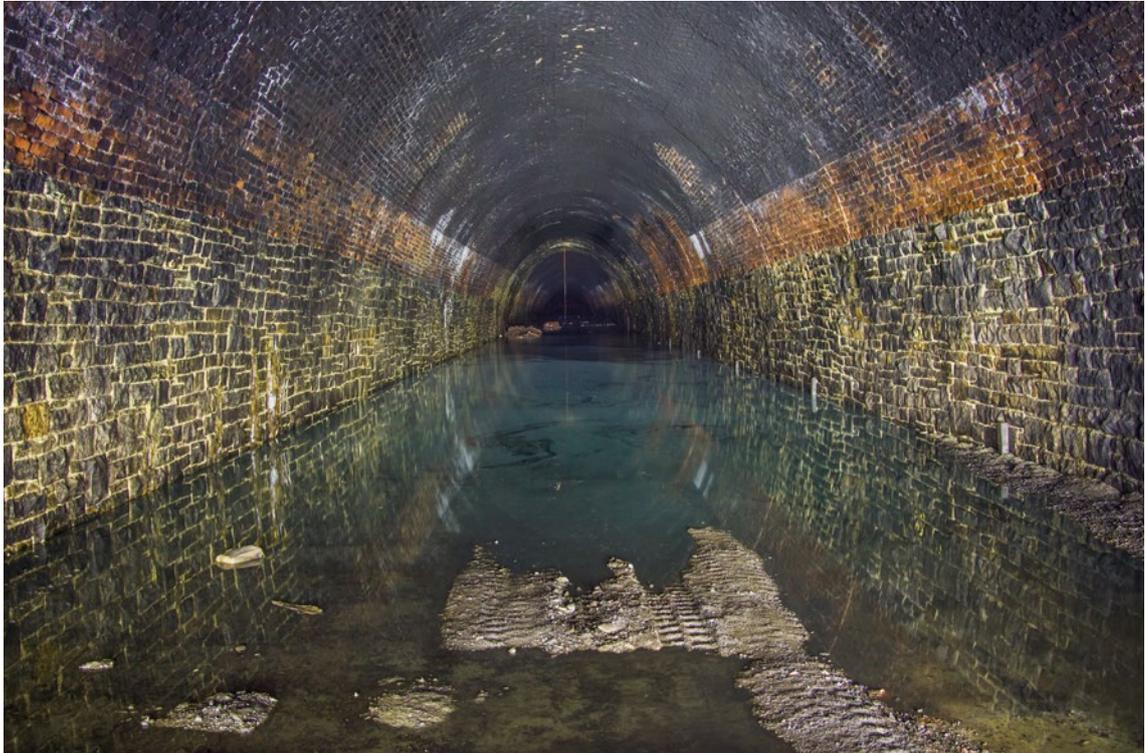
The tunnel is prone to considerable water ingress and, prior to the installation of pumping equipment, the south portal was often fully below water, with the flood extending inwards almost to the midpoint. HRE's current plan to deal with the water involves the permanent retention/operation of the pumps. For this to be implemented, a new agreement would have to be reached with the landowner at the south end of the tunnel following the forfeiture of a lease due to the non-payment of £50 annual rent for three years.

*Floodwater between Nos. 3 and 4 shafts prior to the installation of pumping equipment.*

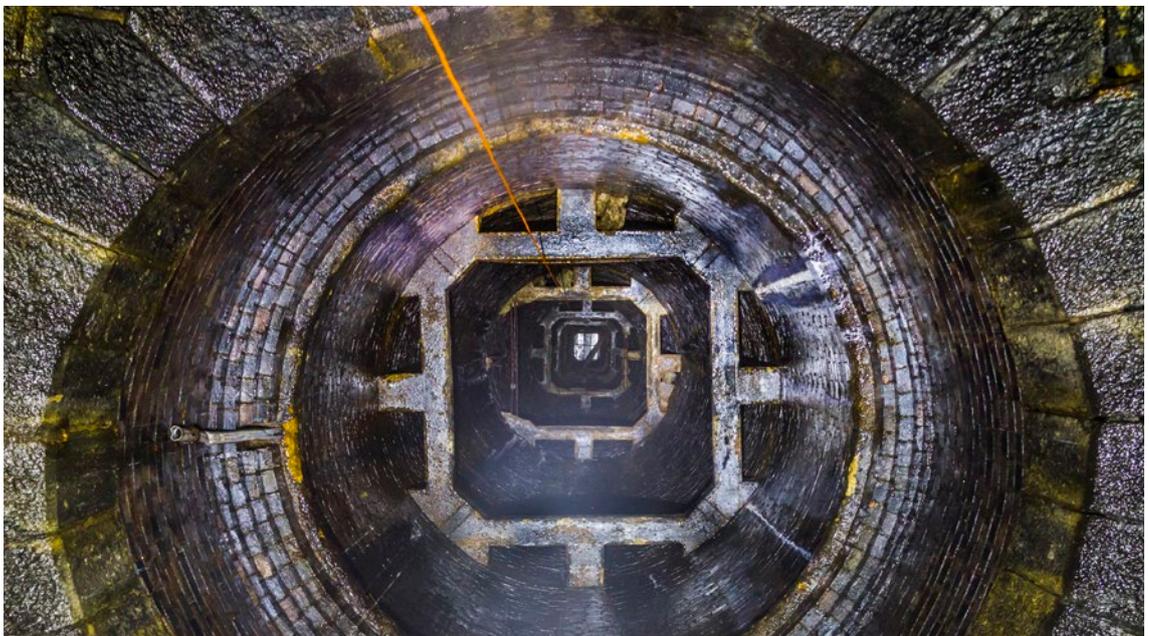
Key defects: Degraded load transfer frames with 15-90% of concrete missing, worse towards top of shaft. Loose blocks supported by reinforcement cages.

*No.3 shaft was internally lined in 1935 and seven reinforced concrete frames installed which are dowelled into the surrounding ground to transfer load (the contract stipulated a minimum distance of 2 feet to ensure "an adequate bearing on solid rock"). As a result, the short-term risks associated with this shaft are negligible.*

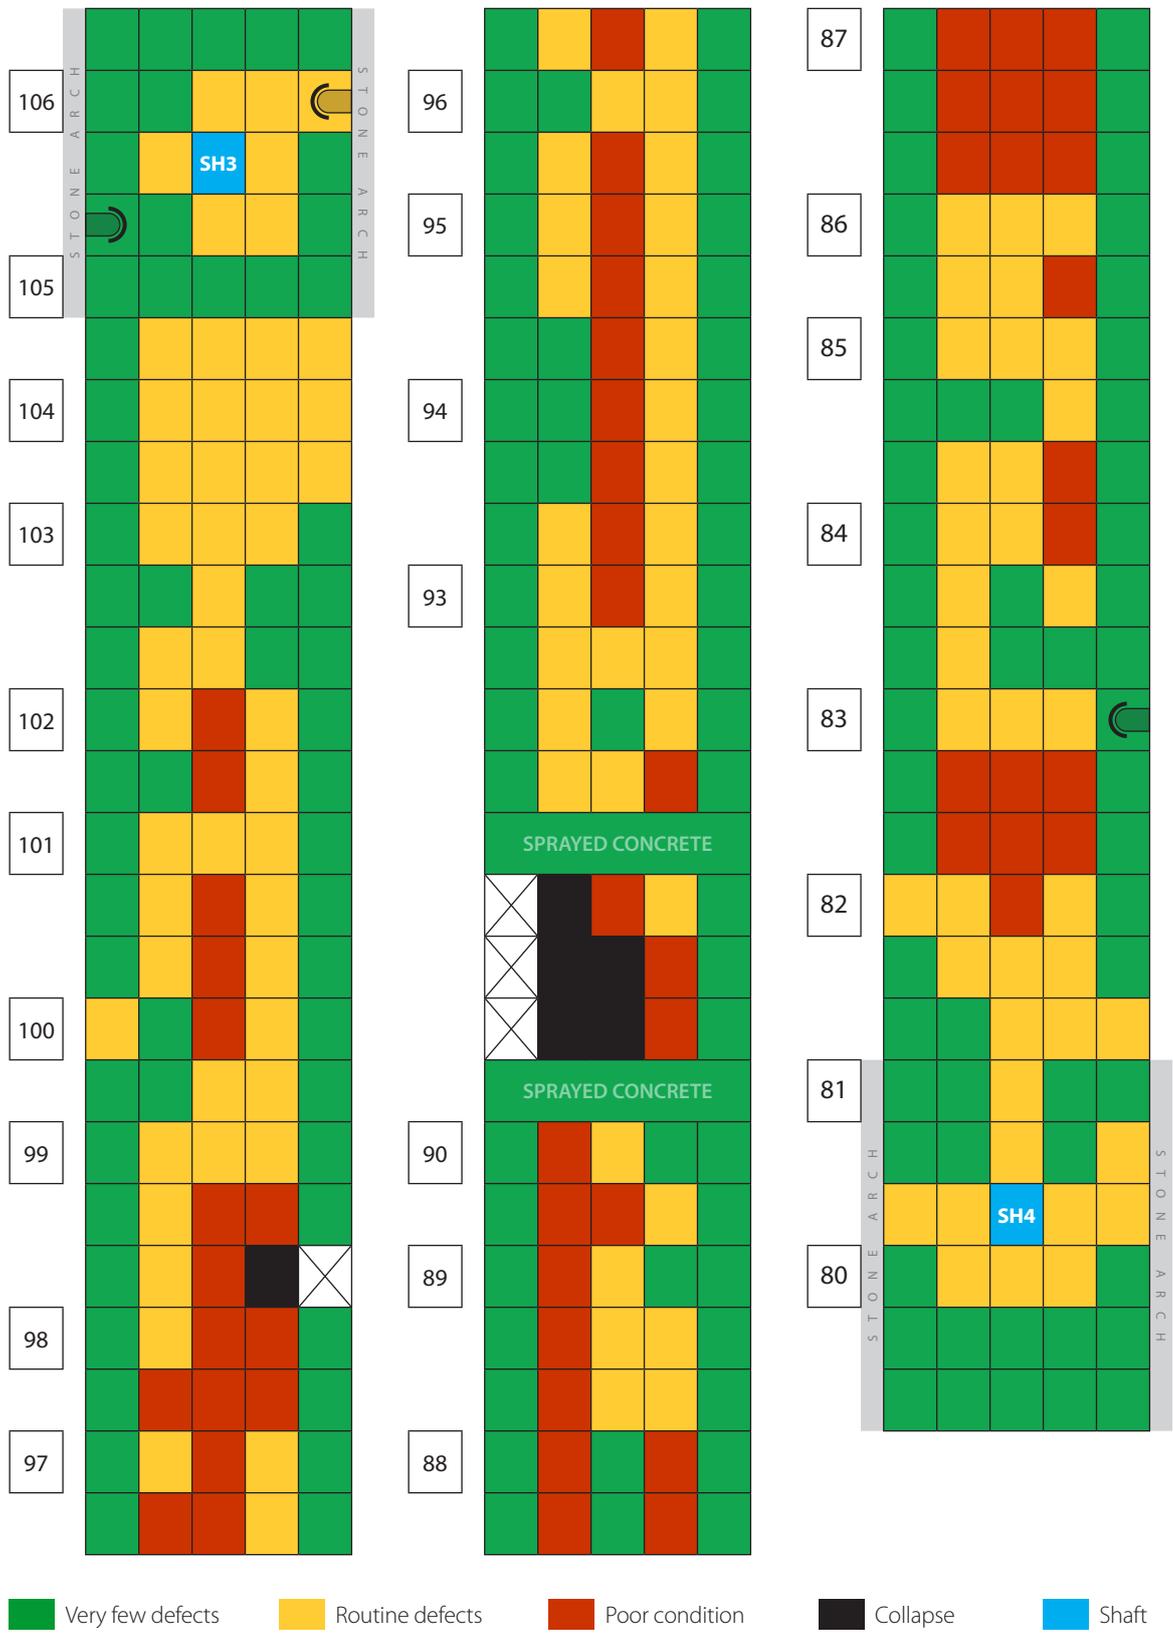
A representation of the lining's condition between Nos. 3 and 4 shafts, based on visual inspections. Each row represents the Down sidewall/Down haunch/Crown/Up haunch/Up sidewall between pairs of construction joints:

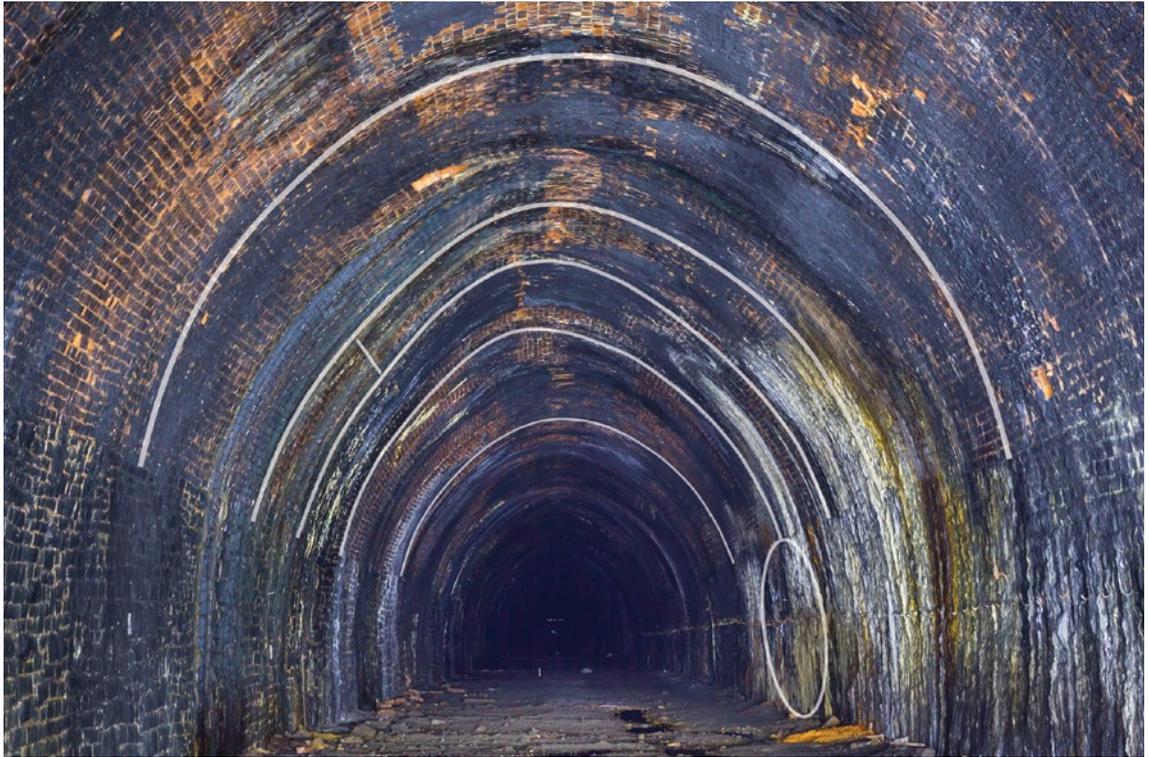
*Distortion of the lining (haunches flattened/arch pushed upwards) between Tabs 31-35, with a bulge in the sidewall.*

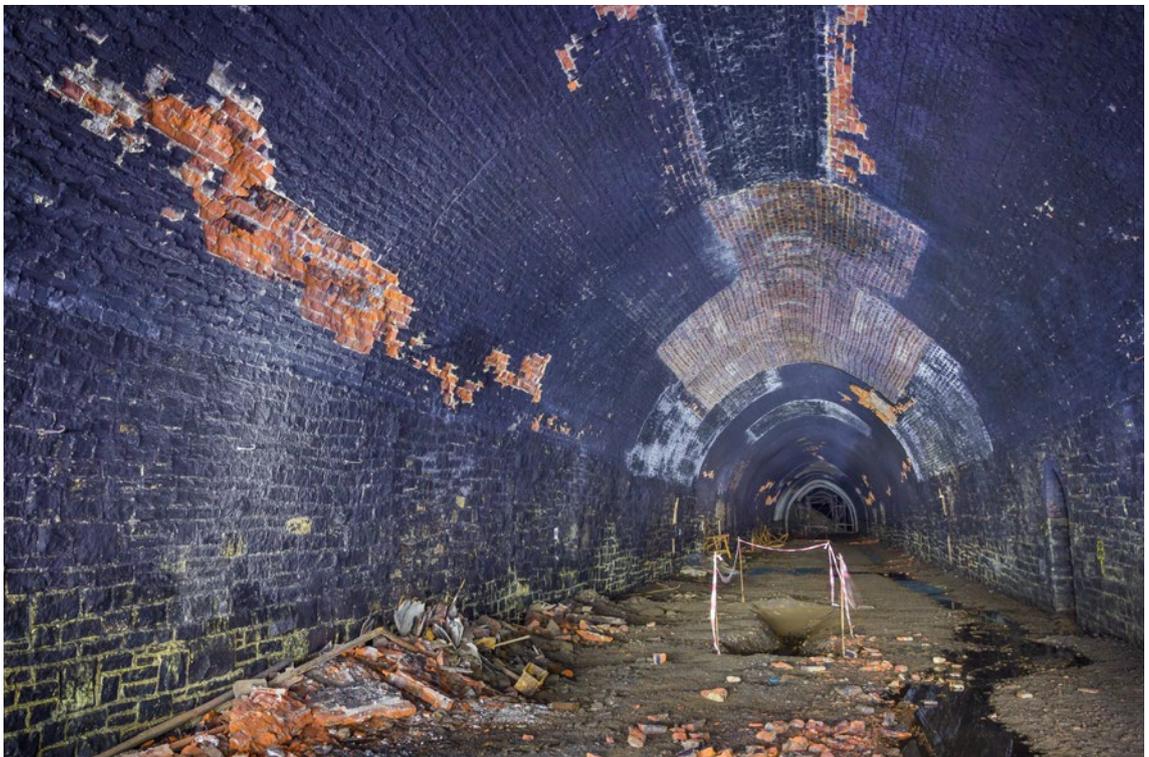
Between and to the north of these collapses are lining fractures, a patch of missing brickwork (Tab 84, Up-side haunch) and areas of compressive stress resulting in the brick faces being blown in longitudinal strips at the haunches and crown. Some of these strips are developing along the edges of patch repairs from the 1920s using engineering brick. ■

*Brick faces blown due to compressive stress at the haunches and crown to the south of No.4 shaft.*

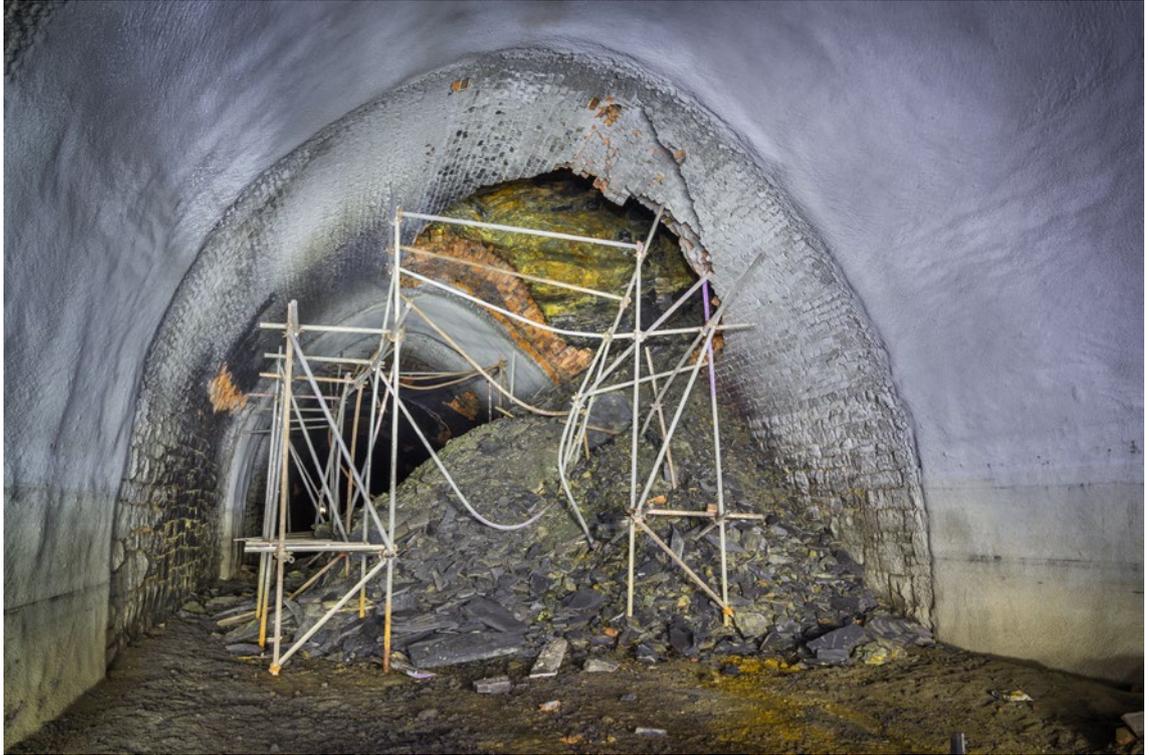
Two partial collapses occurred in February 2013 and the Spring of 2014 at Tabs 90 (Down-side haunch) and 98 (Up-side haunch) respectively, between Nos. 3 and 4 shafts. Patches of the inner ring had already been lost at these locations, with very little mortar visible within the exposed brickwork behind, leading to increased stresses in the lining. Similar conditions are currently exhibited in a much smaller patch at Tab 115 (Down-side haunch).

*The larger of the partial collapses at Tab 90 (Down side), dating from February 2013.*

The smaller of the two partial collapses happened more than four years ago and has not changed to any noticeable extent. The larger collapse occurred five and a half years ago; although its debris heap is now bigger - indicating that more material has since fallen from the void, taking some brickwork with it - it should be noted that there are lengths of sprayed concrete lining to both sides of the collapse and neither is showing any sign of distress. The rock above the void appears competent.

It should be recognised that a repair scheme focussed on risk management need not be as extensive or costly as one designed to facilitate the tunnel's reuse as a public foot/cycle path, as proposed by the Queensbury Tunnel Society. For example, it would be possible to provide additional support both to the ventilation shafts - identified as the source of greatest risk - and adjacent sections of lining.

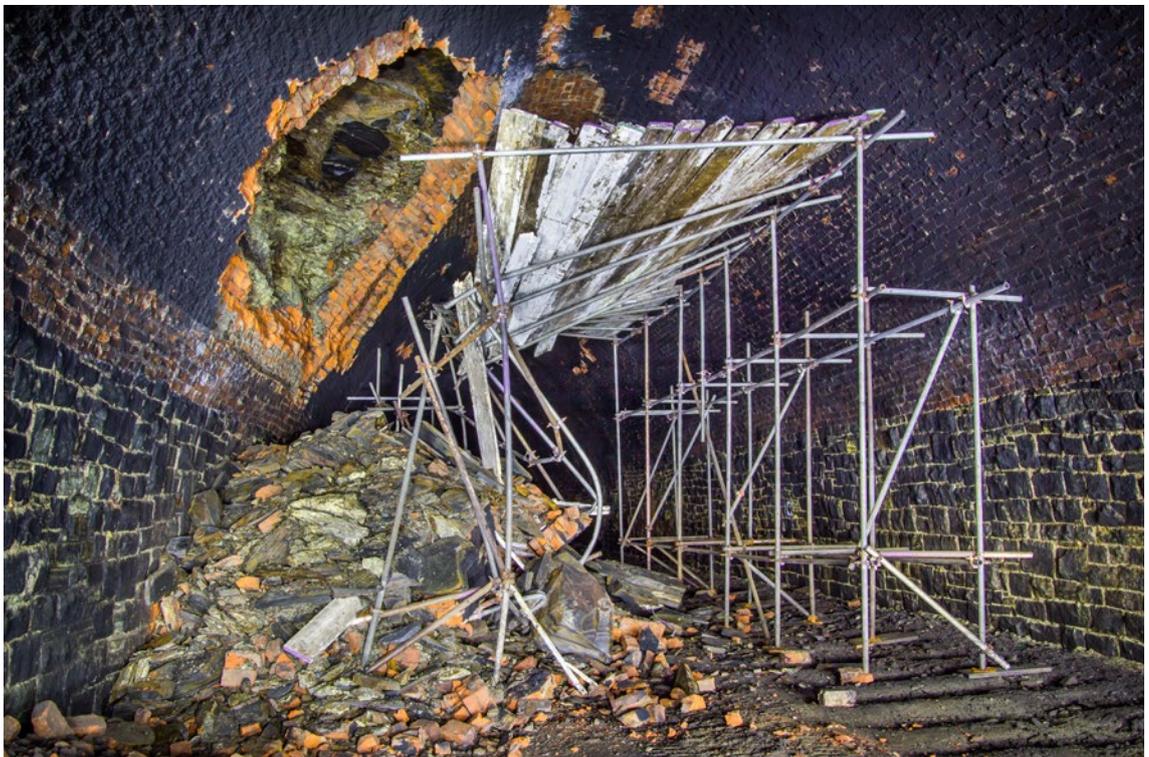
*The smaller partial collapse at Tab 98 (Up side), from Spring 2014.*

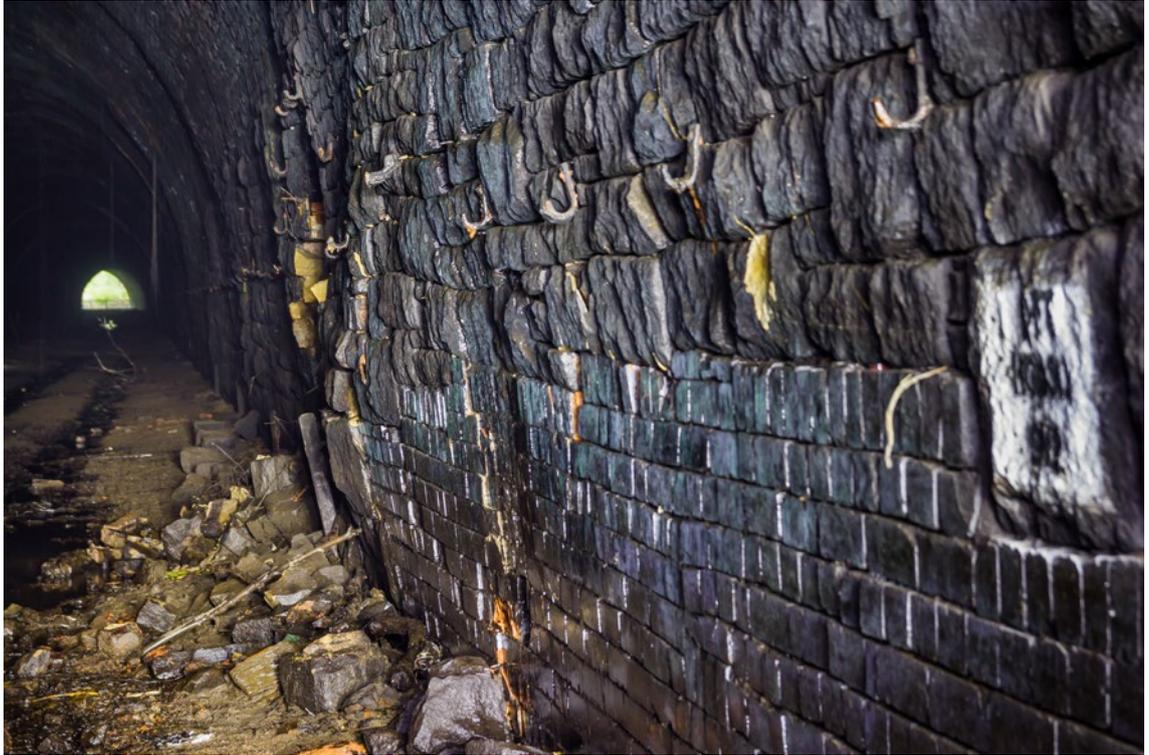
Tunnel lining beneath: Mostly FAIR, locally POOR (generally wet with open joints, bulge in Up sidewall to south side + fractures to refuge/missing masonry facework)

*Bulged sidewall and distorted/fractured refuge (Up side), immediately south of No.2 shaft.*

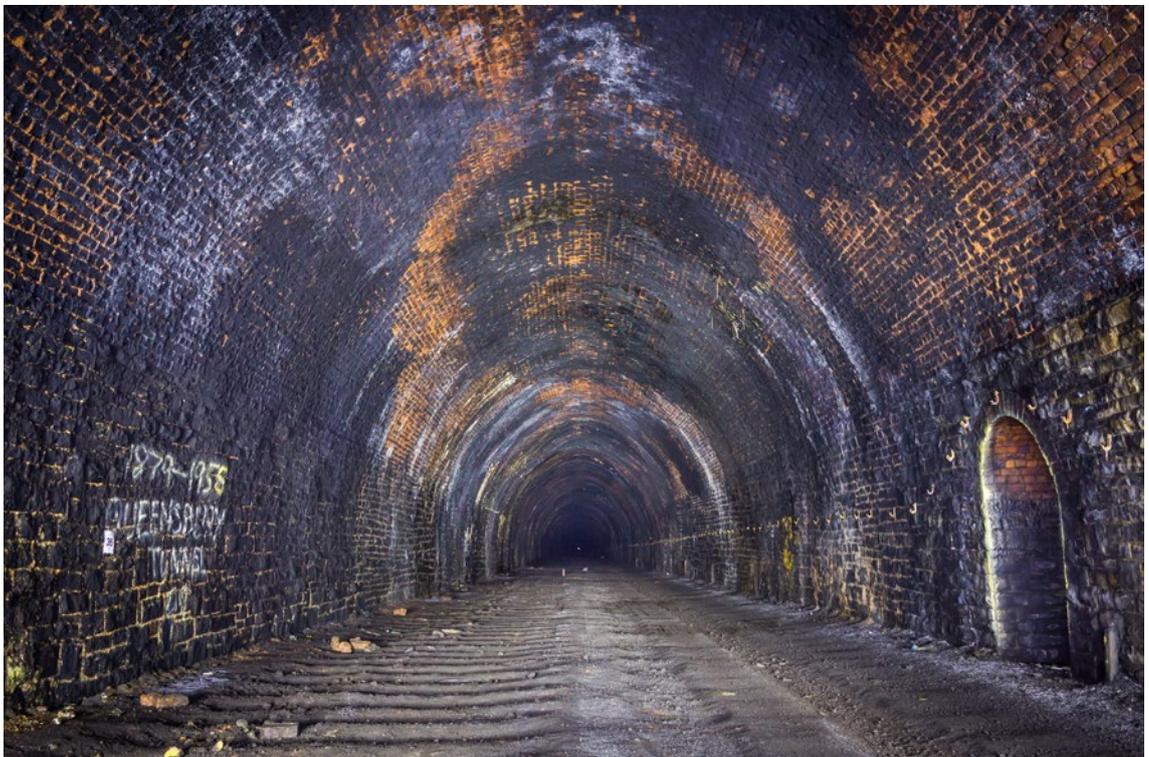
*A view of the tunnel's typical condition.*
