Department  
for Transport

# Future of The Queensbury Tunnel

# Background and Context

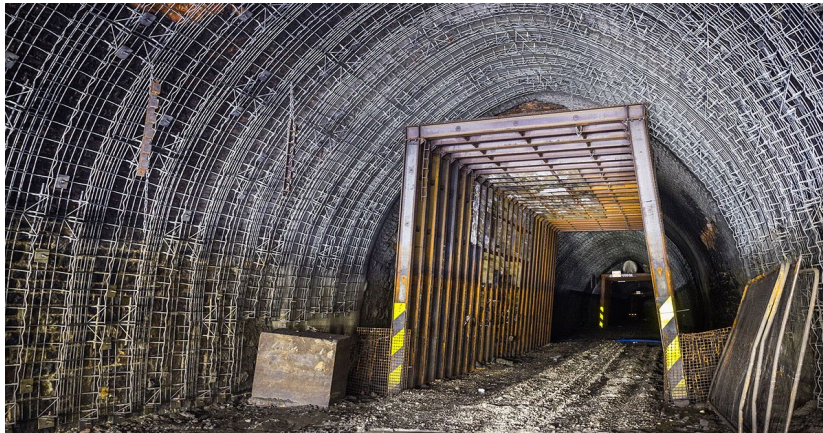
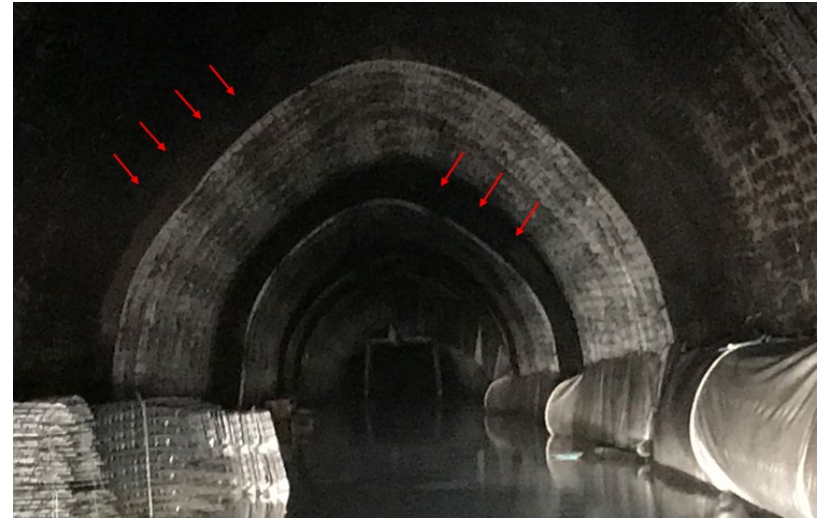
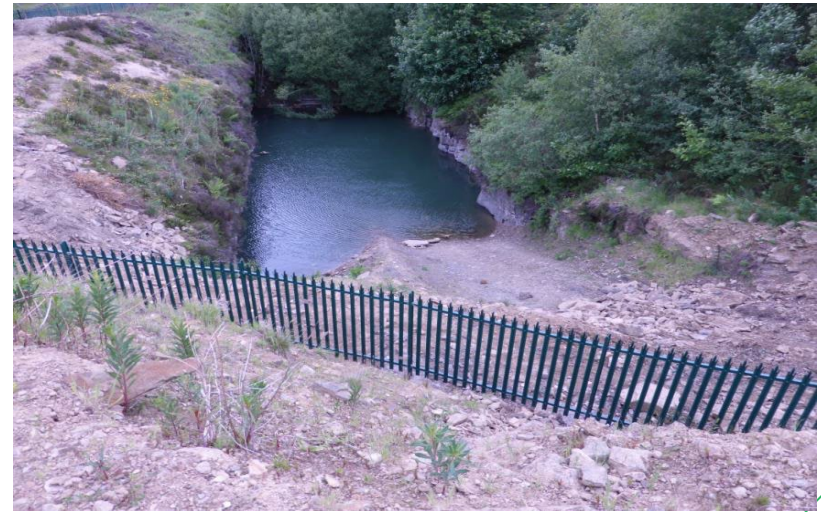
- The tunnel lining continues to deteriorate resulting in falling masonry from the tunnel lining
- Tunnel shafts have deteriorated
- Dangerous gases collect in the tunnel
- The southern portal is completely flooded
- Flooding extends into the middle of the tunnel
- Water continually seeps through the rock and tunnel lining reducing visibility even with the aid of lighting

- A huge amount of work would be required to make the tunnel safe. This would include:
  - Full repair and stabilisation of all shafts
  - Repair including replacement where necessary of the entire tunnel lining
  - Draining and repair to any damage caused by the flooding
  - Strengthening of the tunnel wall where it has become misshapen
  - Work to improve drainage

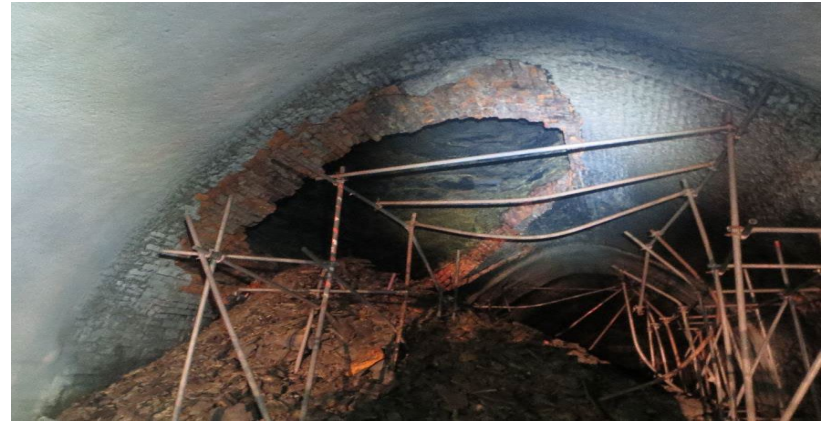
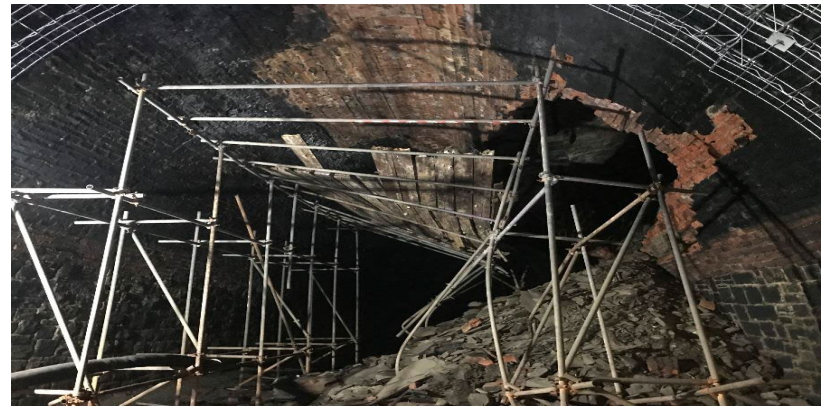
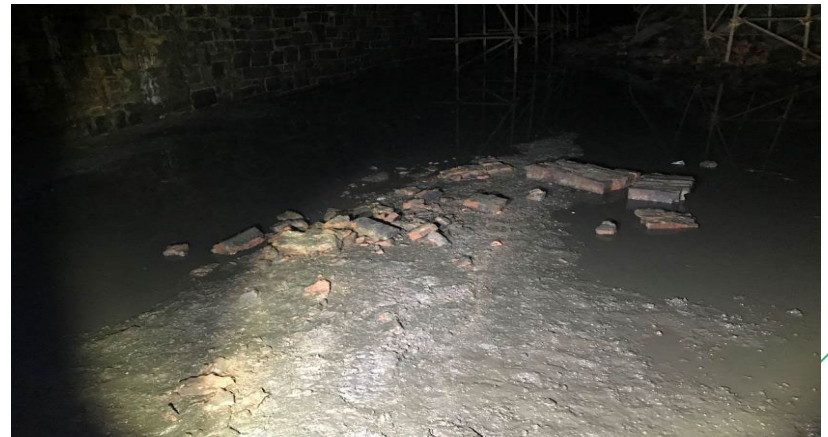
- As inspectors are unable to safely access the tunnel it is not possible properly assess the current level of risk.
- Without further work on the tunnel the following risks could potentially materialise:
  - Risk of shafts collapsing leading to potential destruction of infrastructure above the tunnel – assessed as low based on last inspections but up to date assessment has not been possible
  - Risk of lining collapse leading to potential loss of life for any individual in the tunnel - mitigated by restricting entry
- Coupled with the risk to infrastructure above the tunnel is the risk to engineers inside the tunnel when making assessments of its condition due to:
  - Single point of access/egress
  - Rising gas levels
  - Risk of injury from falling masonry

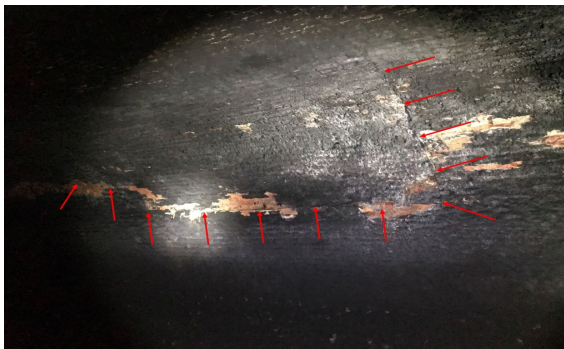
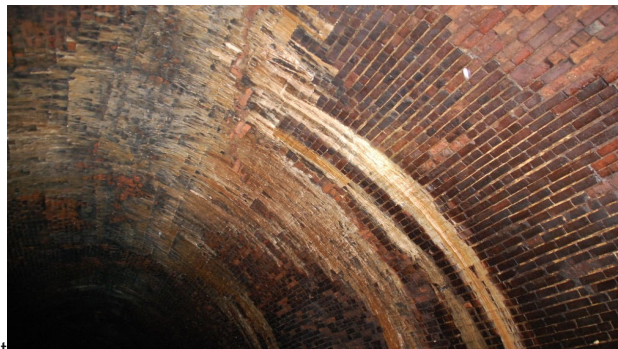
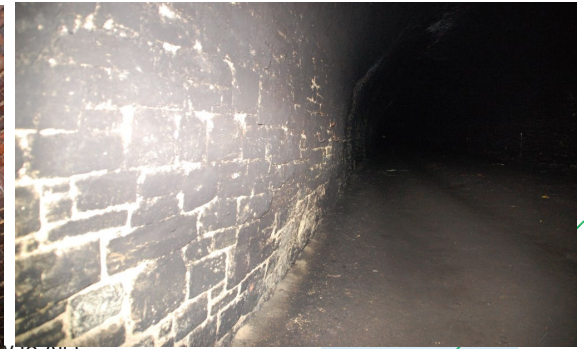
- Further works would be required to bring the tunnel to the standard required for a greenway
  - Installation of power for lighting and air flow
  - Repair of the tunnel bed
  - Repair of the tunnel entrances
  - Significant work on the tunnel approaches would be required in particular the flooded southern portal
  - Significant work to ensure drainage is compatible with the need to maintain a safe active travel route.
