Queensbury Tunnel

Phase 2: Technical Summary
Structure Number: HQU/3D

City of Bradford Metropolitan District Council

Project number: 60582061
Report: 60582061-REP-006
Issue 02

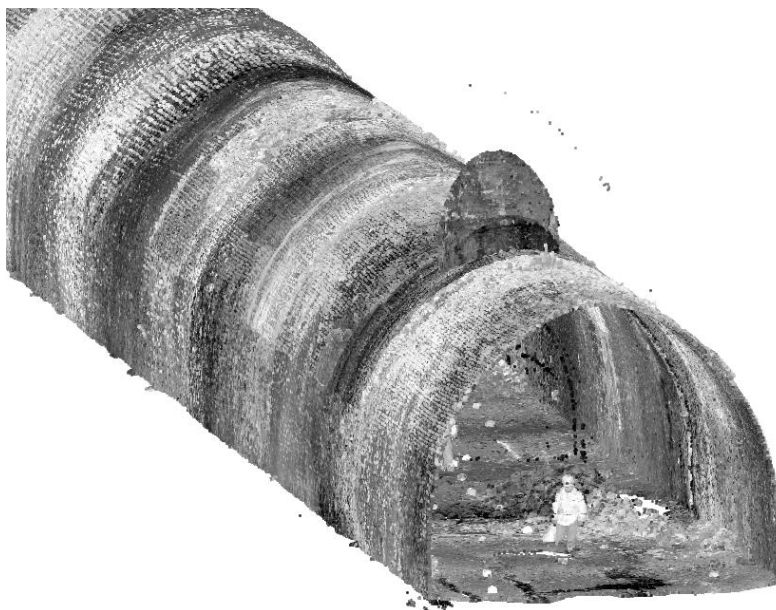
Figure 5: Point Cloud Survey Extract CH 80m facing northwards

A three dimensional ‘point cloud’ survey was undertaken in lieu of two dimensional laser surveys at specific chainages. The point cloud survey is capable of being interrogated at an infinite number of locations and cross sections and yields the maximum amount of data for assessment.

A typical extract from the model, in which individual bricks/blocks can be interrogated, is shown in Figure 5.
