# Queensbury Tunnel

Risk to the Community

J U L Y 2 0 1 8

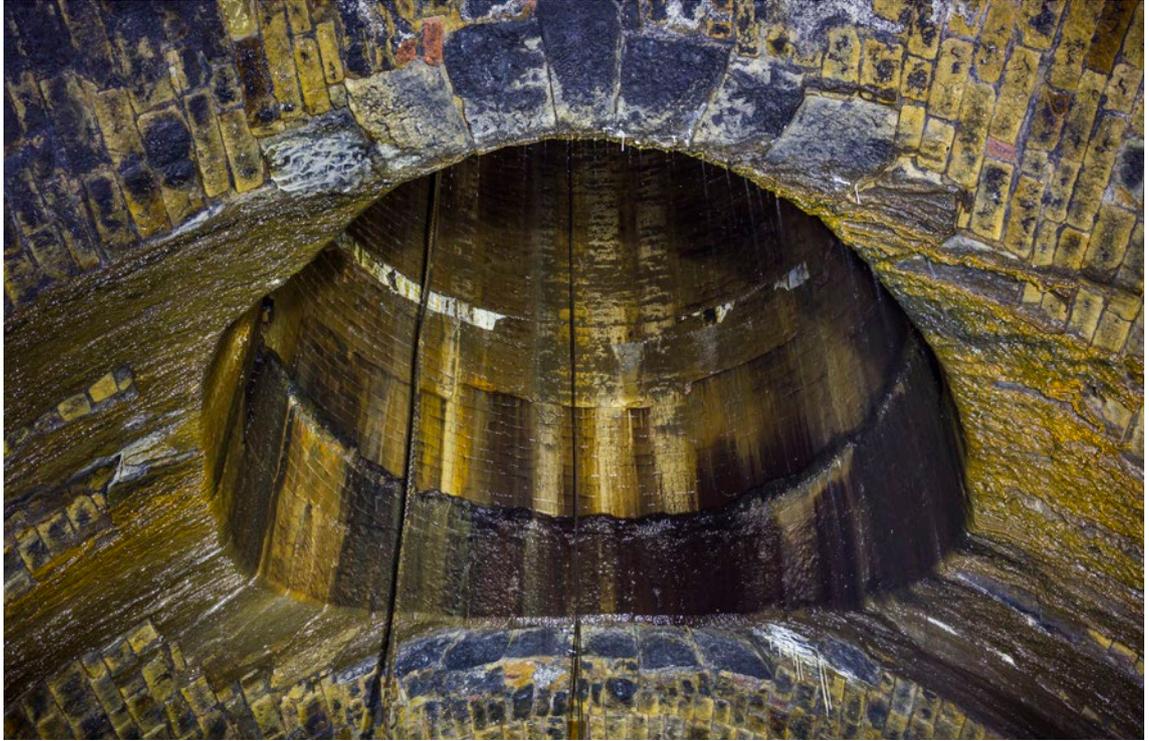
The typical weight of a shaft lining (assuming 9 feet in diameter, two bricks in thickness) is historically recorded as approximately 3.4 tonnes per yard in depth. Thus, a 350ft/106.7m deep shaft with this specification could be estimated to have a weight of almost 400 tonnes.

In structural terms, a shaft lining is generally supported by a kerb of masonry, brickwork or cast iron built into the tunnel lining which allows the dead load to be transferred into the ground through the arch, sidewalls and foundations. However some of the load is also dissipated by friction between the extrados of the shaft lining and the surrounding ground. The extent of the friction depends largely on the type of ground through which the shaft was sunk and whether voids are present behind the lining.<sup>1</sup>
