Queensbury Tunnel Options Report

The Historical Railways Estate (HRE), part of Highways England, examines and maintains around 3,200 disused railway structures. Of that number, the 2,501-yard (2,287 metres) long Queensbury Tunnel - between Bradford and Halifax in West Yorkshire - has the highest risk profile. This is due to its deteriorating condition, difficulties with access and the close proximity of dwellings to four of its construction shafts.

Current condition

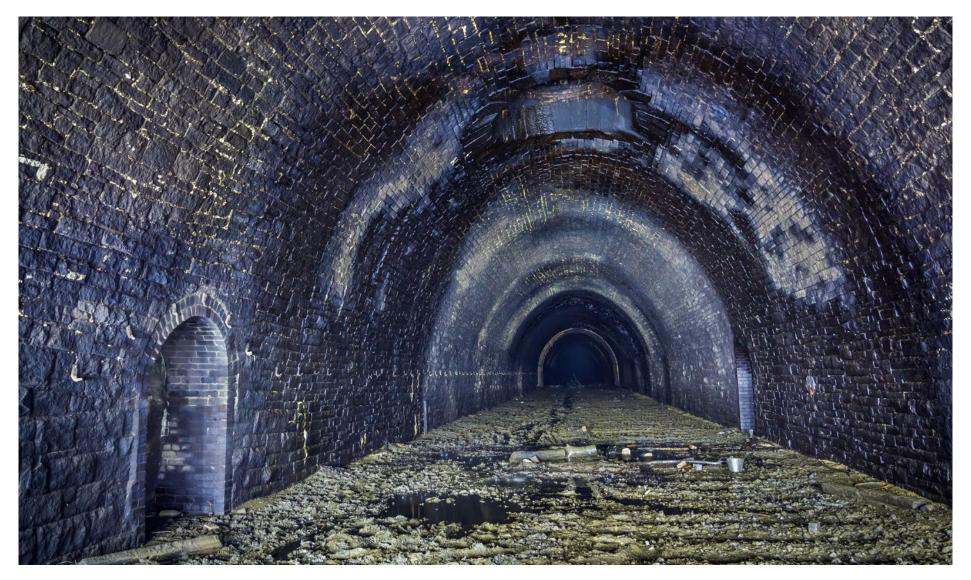
Section of arch ribbing with some laggings in situ. Spalled/wet/missing brickwork at crown.

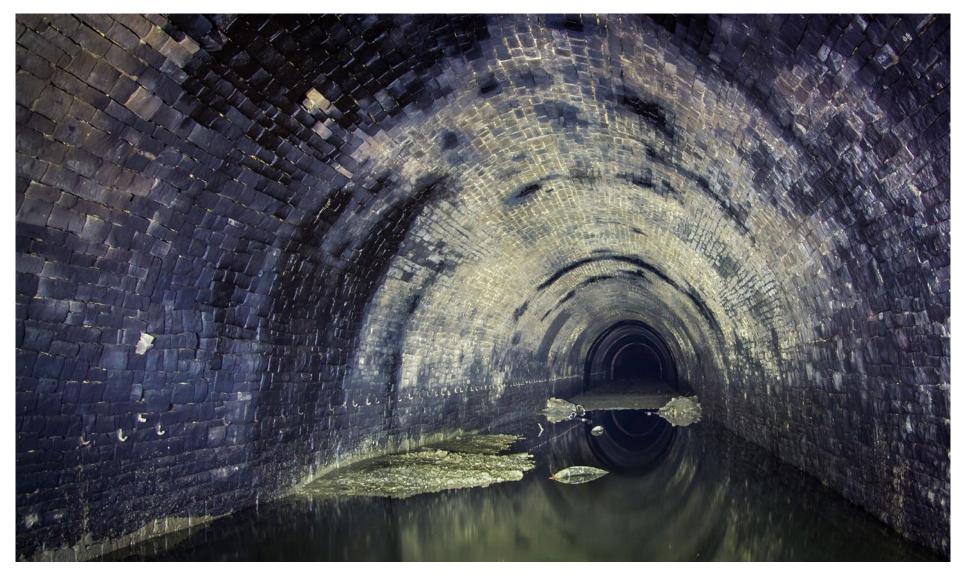
General view showing the form of construction between the south portal and No.1 shaft. Note loose/hanging stones at U/S haunch.

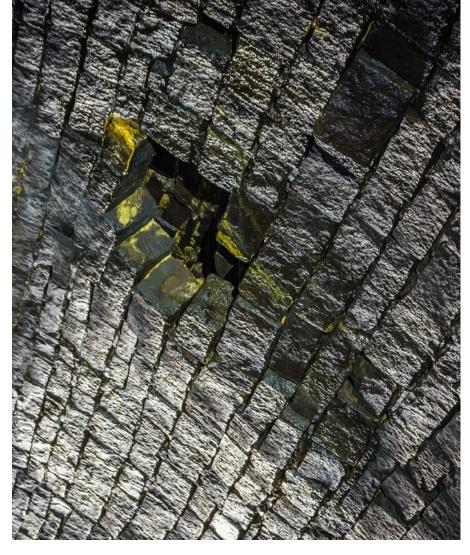
Missing stonework at D/S haunch.

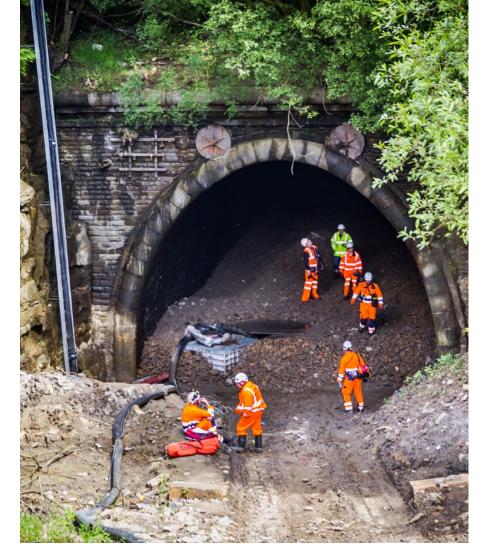
View of south portal after dewatering. Note pipework (left) for longterm pumping arrangements. Pumps are located in a sump in the tunnel entrance.
